RM No. E8F29

OPERATING TEMPERATURES OF I-40-5 TURBOJET ENGINE  
BURNER LINERS AND THE EFFECT OF TEMPERATURE  
VARIATION ON BURNER-LINER SERVICE LIFE

By H. D. Wilsted, Robert T. Duffy  
and Ralph E. Grey

August 23, 1948

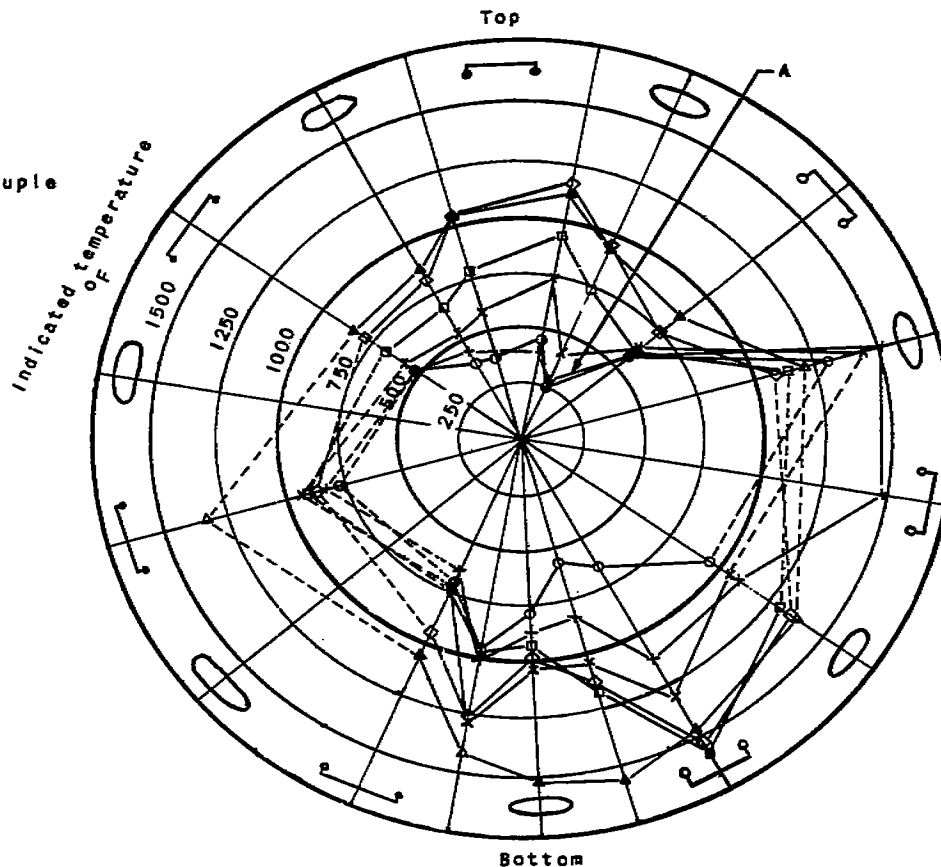
sections containing the louvers and air-intake holes, respectively. An examination of the data shows that the highest indicated burner-liner temperature recorded in these investigations was 1590° F, as shown in figure 9 at an engine speed of 11,500 rpm. This peak temperature occurred in the thermocouple belt  $9\frac{1}{2}$  inches from the inlet end of the liner near the critical section.

Temperature gradients as great as 700° F per inch of circumference are shown in figure 9 (point A). The high-temperature gradients from point to point in the burner liner are probably the cause of failure, the principal factor at the present time limiting the service life of the gas-turbine engine. Any process or method that will remove heat from the hot spots or give a more even temperature distribution such as the use of heavier gage metal for the liners to more rapidly conduct heat away from the hot spots or the use of cooling fins to remove heat from the high temperature areas should add materially to the burner-liner service life.

Figure 9. - Circumferential burner-liner temperature distribution near hottest temperature belt on burner liner A at various engine speeds. Average diameter of liner, 5.5 inches. (Dashed lines indicate missing temperature readings as a result of thermocouple failure.)

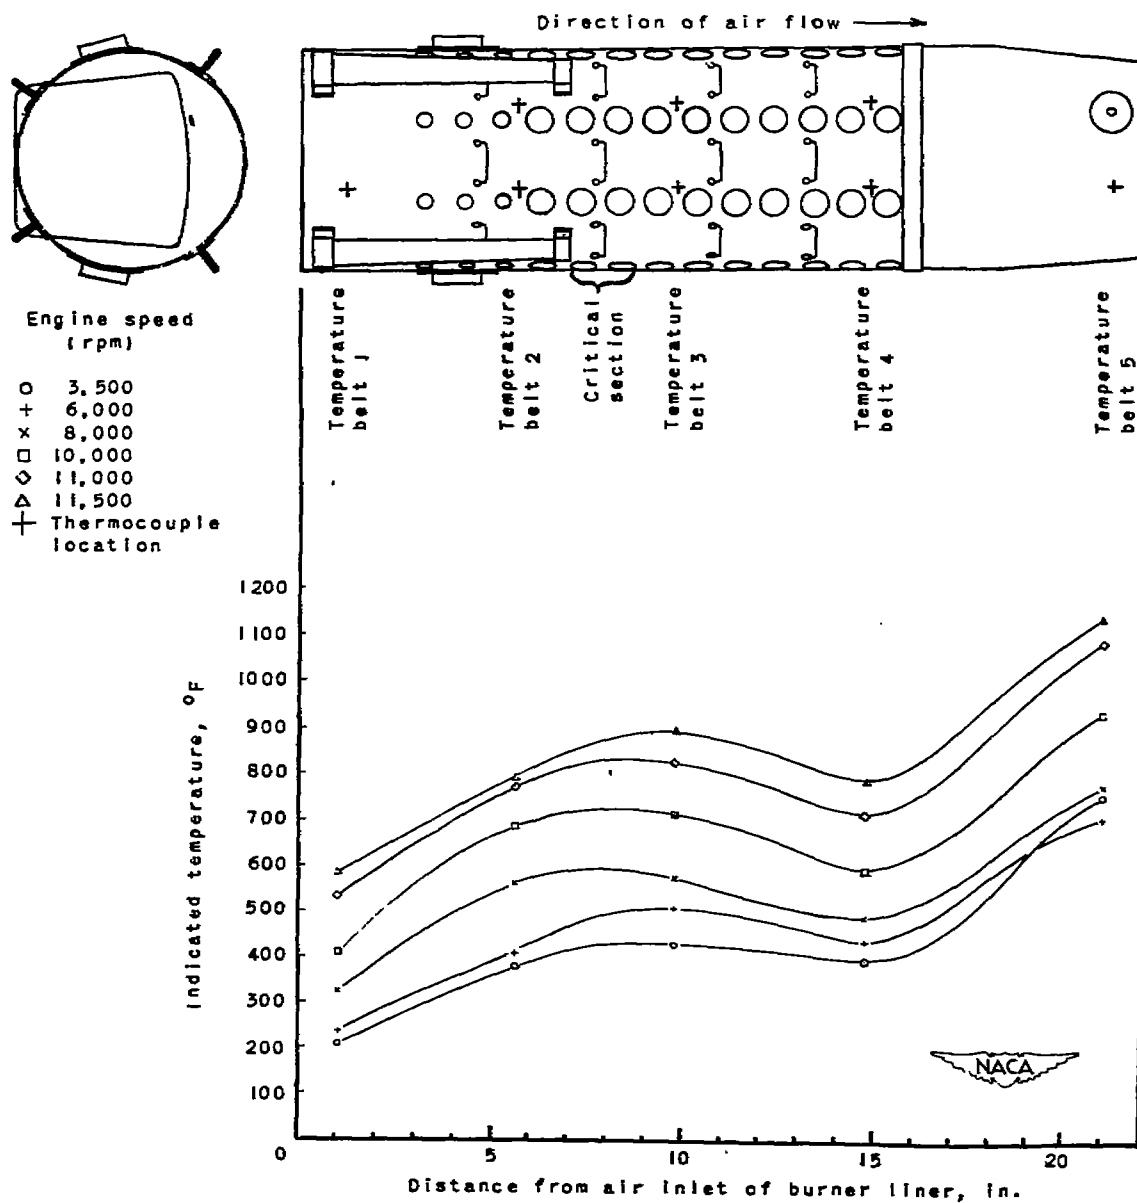
figure 11. The average values show the following trend: a peak in temperature about one-third the length downstream on the liner with a greater peak occurring at the liner exit. It is in the region of the first-mentioned peak temperature that liners have failed in NACA investigations. These failures occur in the form of fractures and severe warping extending from the louvers to the air-intake holes at a section approximately 8 inches from the inlet end of the liner. This failure belt will hereinafter be referred to as the "critical section." Inspection of service liners has also shown failures at other locations between air-intake holes and louvers but in every case of this type there was a more serious failure at the critical section.

Figure 11. - Temperature variation along length of burner liner B. All points are average of belt temperatures.

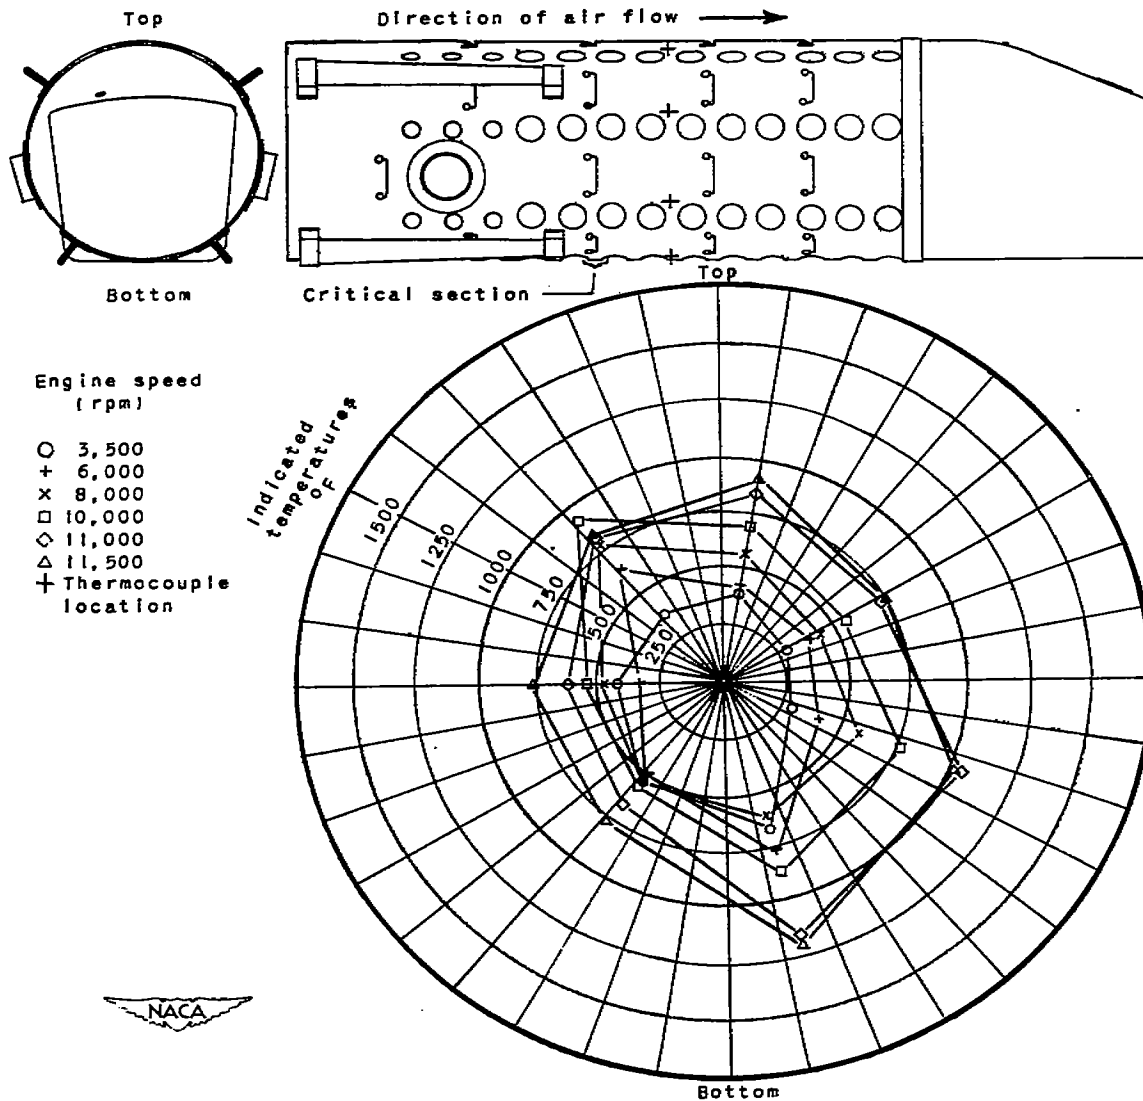
The circumferential temperature variation nearest the critical section is presented in figure 13. An appreciable temperature variation occurs with a decidedly high-temperature region located at the lowest portion of the burner liner as installed in burner 12. This peak agrees with that of figure 9. The high-temperature region is behind the right-hand interconnector fitting. The axial temperature distribution along this section is shown in figure 14 and the temperature behind the left-hand interconnector fitting in figure 15. These figures also show the maldistribution indicated in figure 13. The peak temperatures behind the right-hand interconnector fitting at the higher speeds are of the order of 500° F greater than the corresponding section behind the left-hand interconnector fitting. Inasmuch as air-flow patterns approaching the burner have not yet been obtained, it is not known whether this shift is a result of air-flow variations or maldistribution of fuel.

Figure 13. - Circumferential temperature distribution near-critical section of burner liner B at various engine speeds.
